# BACK TO NATURE

## Rehabilitating aging infrastructure in environmentally sensitive areas

*Kenneth H. Nilsen and Peter Sanchez*

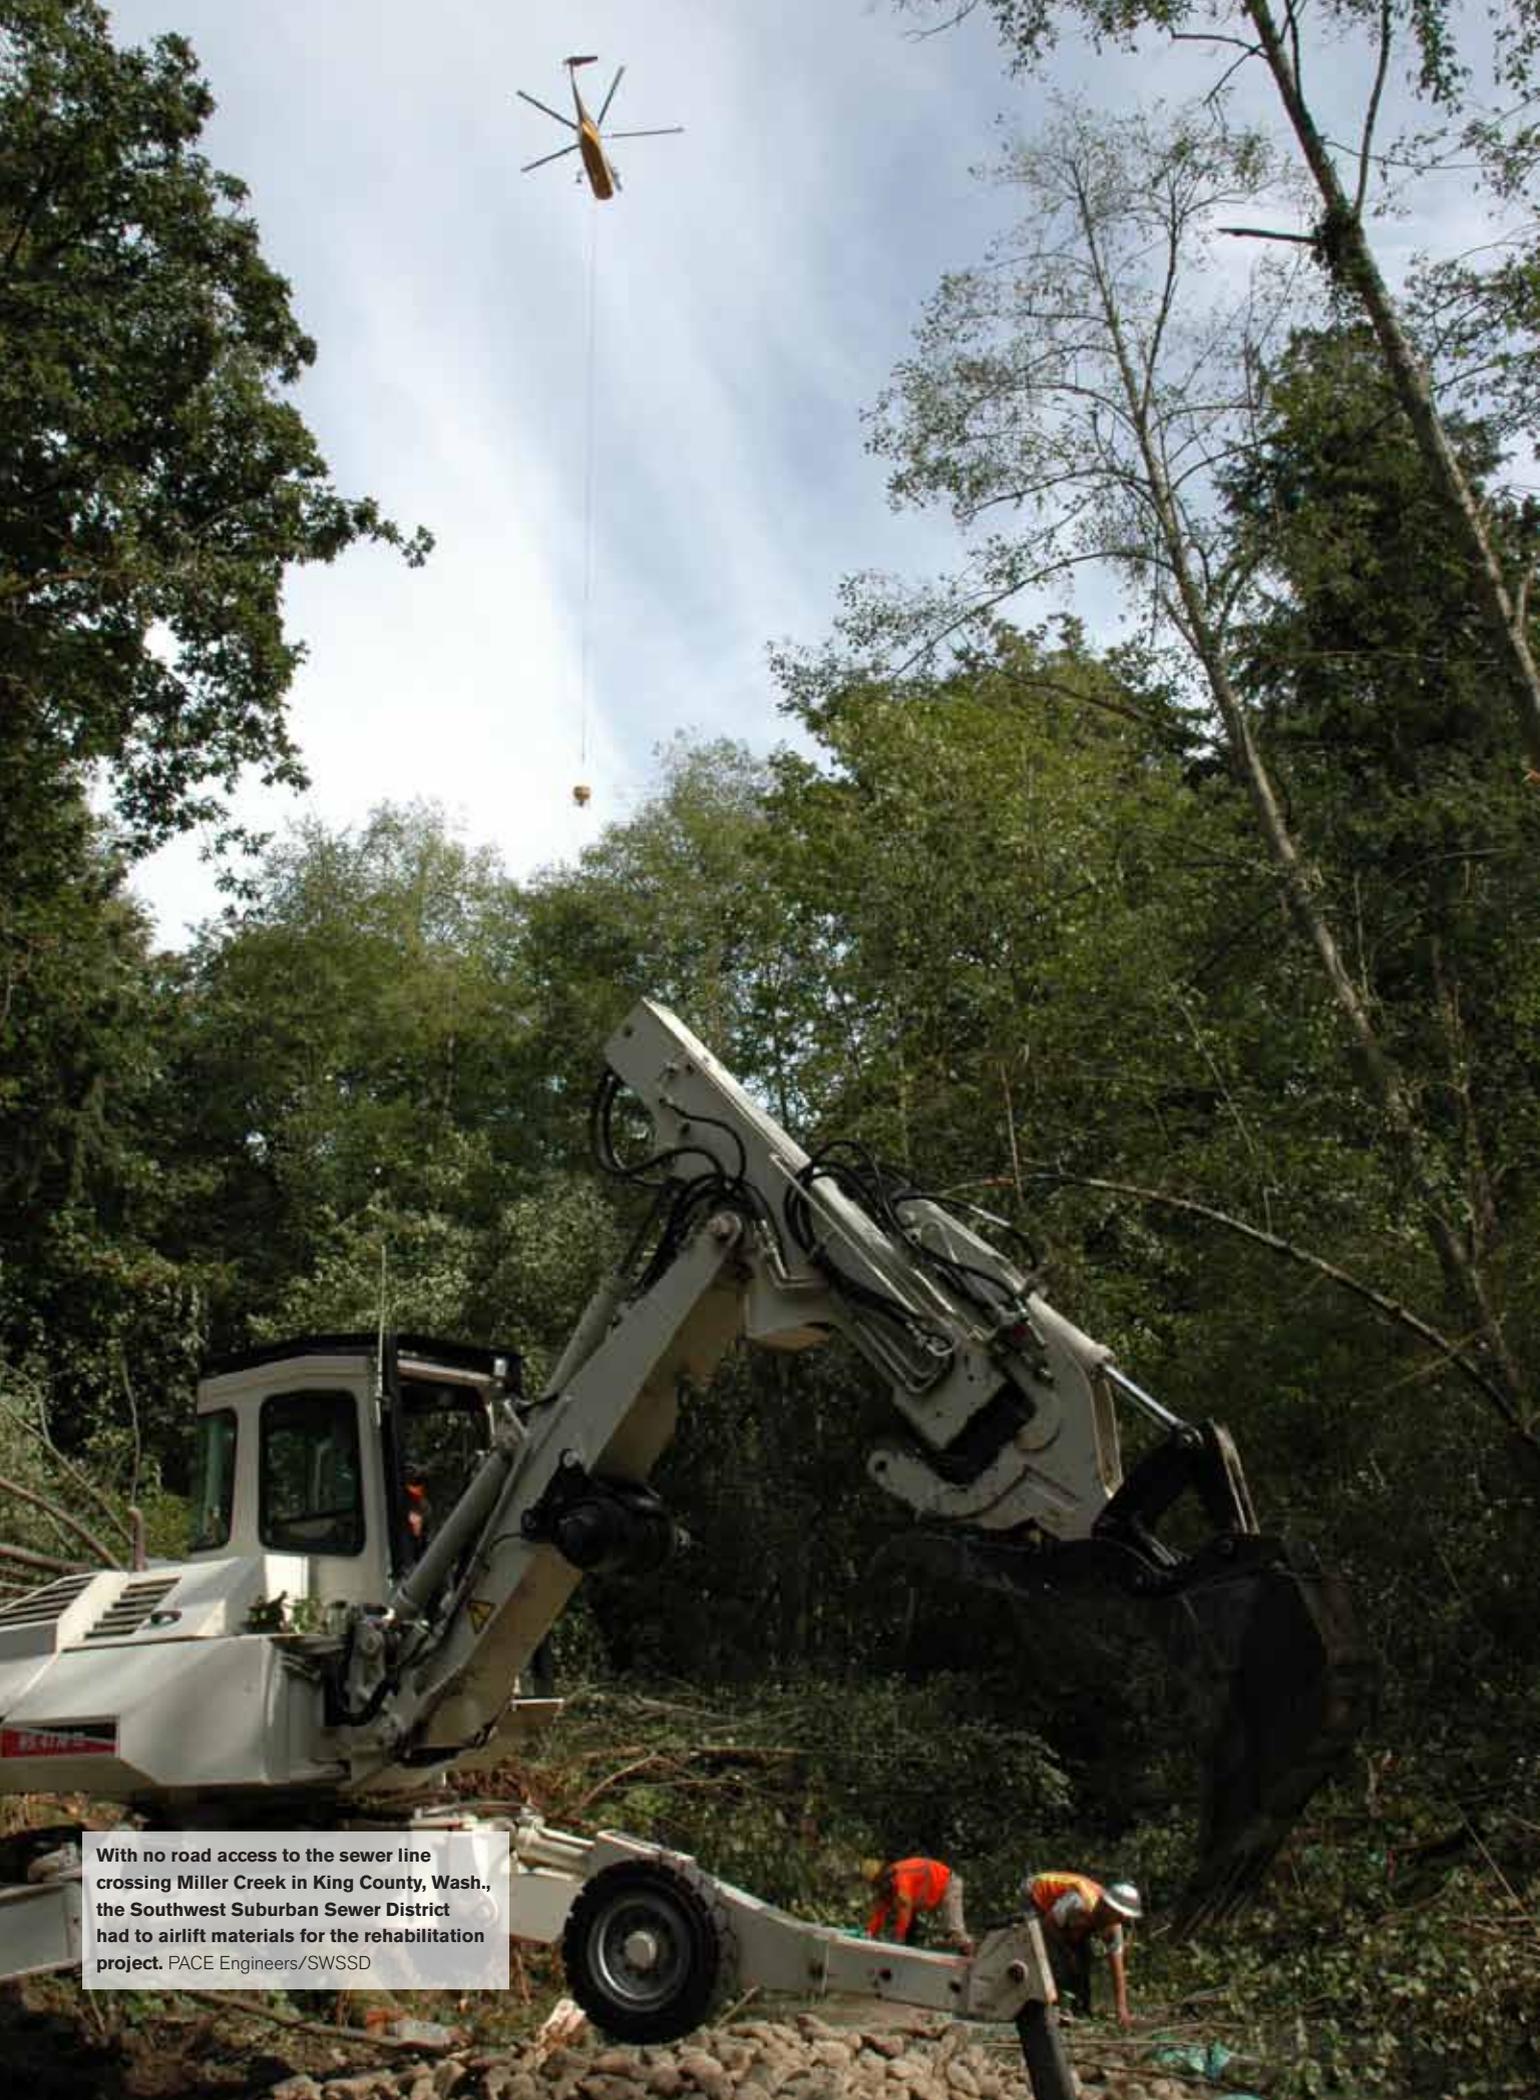
With no road access to the sewer line crossing Miller Creek in King County, Wash., the Southwest Suburban Sewer District had to airlift materials for the rehabilitation project. PACE Engineers/SWSSD

After lengthy deliberation, Alternative 1 was selected. Suitable mechanical excavating and lifting equipment would be airlifted by

helicopter into and out of the area of the repairs, as would the necessary materials (boulders, large woody debris, streambed gravel, and anchoring components). This approach would minimize the area of disturbance and could be completed in the shortest possible construction period because virtually the entire project time would be spent working directly on the repair/restoration. This alternative also would have the shortest potential period for permit review because the area of disturbance would be small. The three other alternatives had combinations of highly problematic logistics, unlikely permitting success, a larger environmental footprint, and longer and/or costlier construction periods.

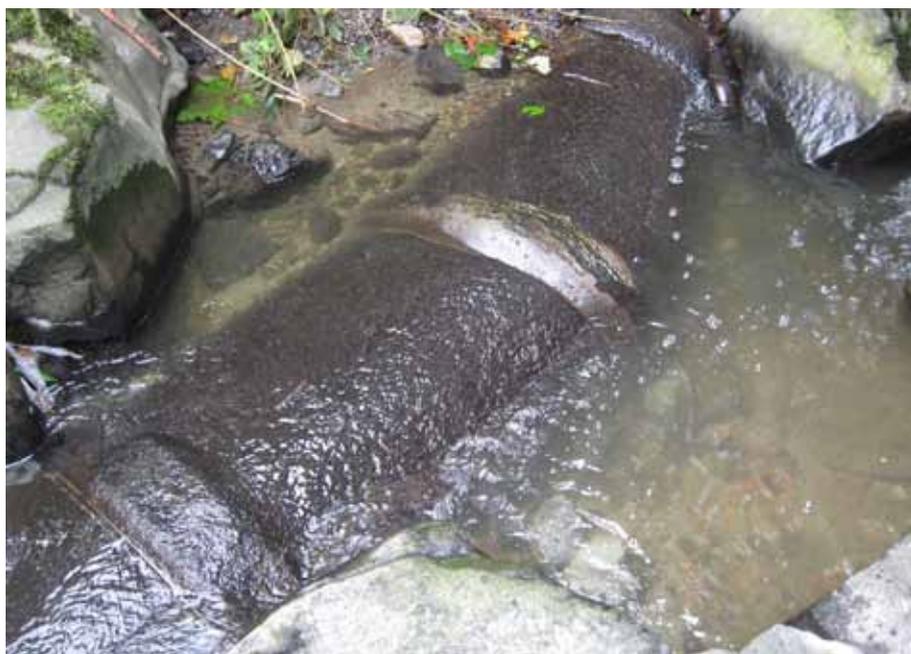
**District staff discovered that sewer lines and several manholes, which previously were buried beneath the stream, had been exposed.** PACE Engineers/SWSSD

During a maintenance walk in June 2007, following a winter of record rainfall, district staff discovered that several manholes in the Miller Creek ravine were now fully exposed to high stream flows, and that an unrestrained 22.5-degree vertical-horizantal bend that had previously been buried 1.2 to 1.5 m (4 to 5 ft) below the stream was exposed and in jeopardy. Any further down-cutting or movement of this sewer line could lead to a total separation of the trunk line, causing catastrophic environmental impacts to a major salmon spawning creek.

The district was previously aware that the streambank near Manhole (MH)-12 had eroded, leaving the upper 1.5 m (5 ft) of the manhole fully exposed to high stream flows. In this June 2007 inspection, the district staff noted that a portion of the sewer trunk line near MH-15 also was exposed. Following that initial reconnaissance, PACE Engineers Inc. (Kirkland, Wash.) was contracted to conduct a topographic survey of the stream and sewer line from MH-11 to MH-17, and identified approximately 43 m (140 ft) of pipe that were at risk of damage. The project team believed this risk would be very high if corrective action was not immediately taken before the 2007 winter flows.

To stabilize this reach of Miller Creek and protect the pipe, it was important to assess why the stream down-cut in this reach. A stream geomorphologist and a surface-water engineer walked the site several times in July to ascertain the reasons for the stream down-cut and assess what could be done to fix the stream. It appeared that two main factors contributed to this problem: The stream was constrained in

width due to the geological conditions and the riprap revetment on each streambank, and this narrowing of the channel led to very high stream velocities and corresponding scour. There also was a grade change in the stream profile in this reach, which, combined with the high velocities, led to head-cutting of the stream channel and created a complete barrier to upstream fish migration.

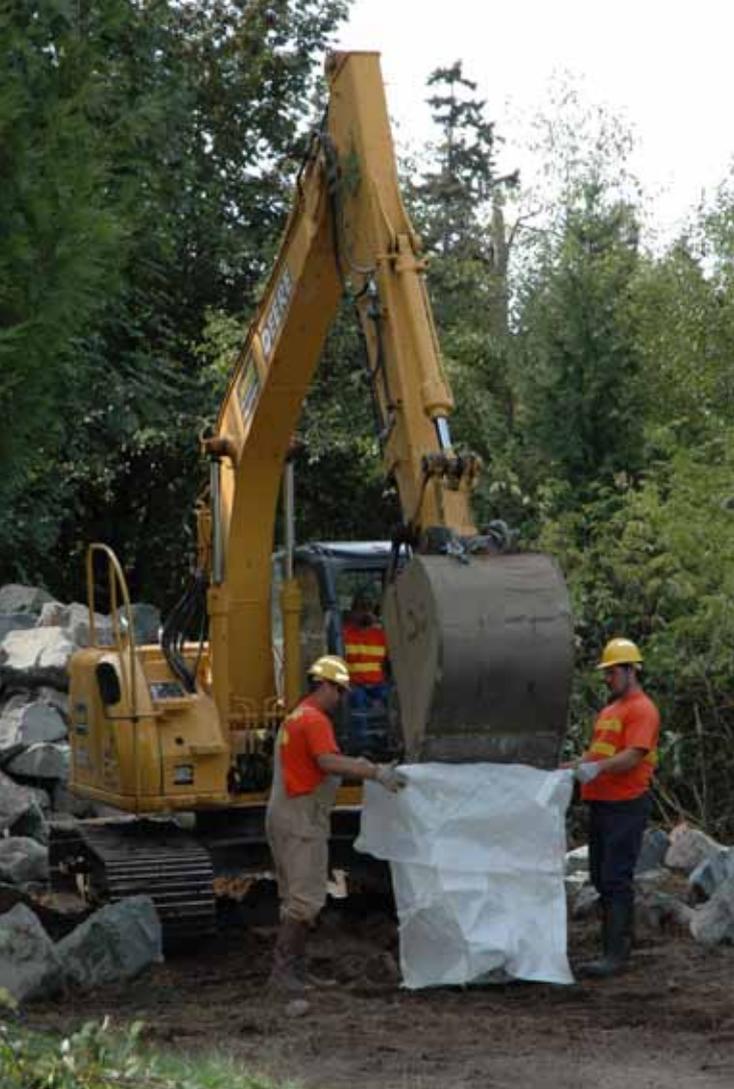
**Boulders were bagged at the staging area and then airlifted to the project site.** PACE Engineers/SWSSD

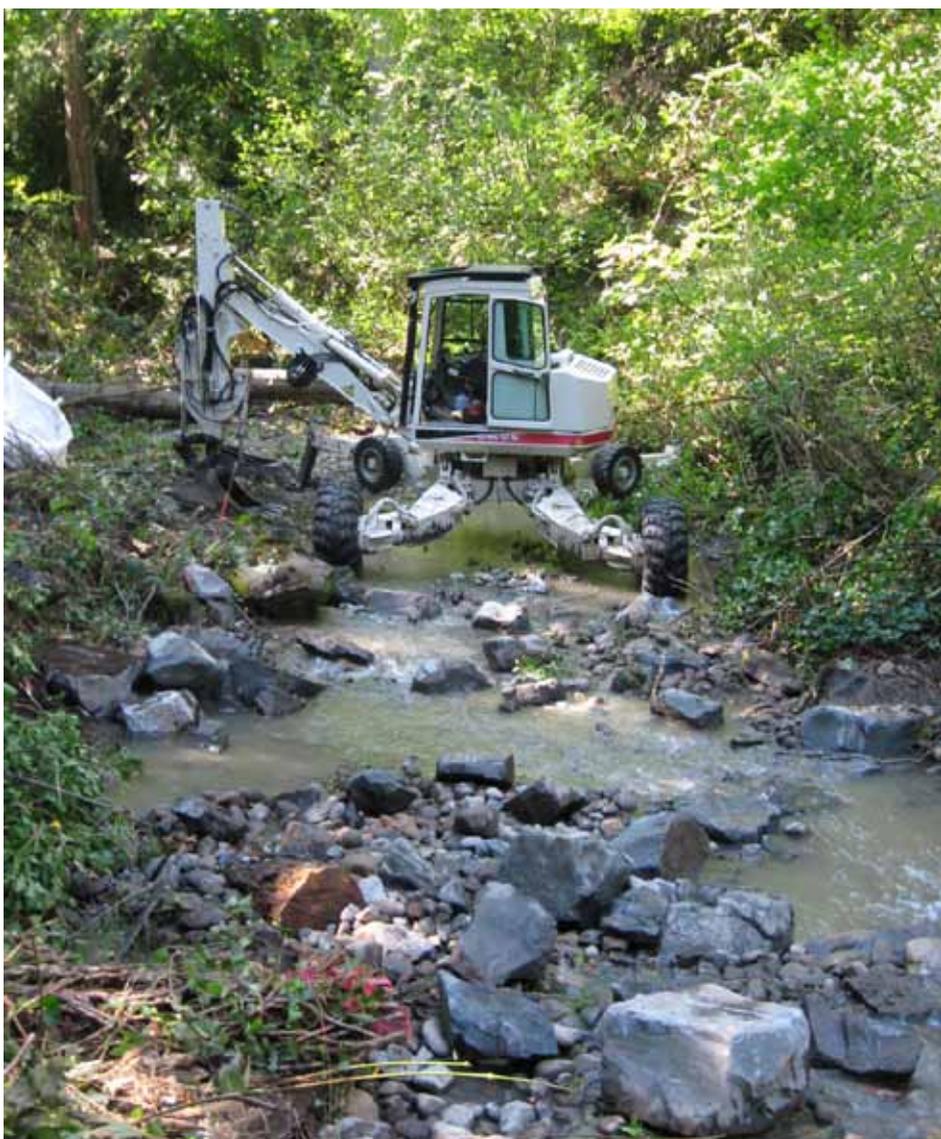
The Spyder Hoe excavator was chosen for its ability to “walk” up the creek channel with minimal environmental disruption. PACE Engineers/SWSSD

To minimize impacts to the stream, riparian corridor, and sewer line, the project team had recommended that the placement of material be done with a special excavator called a Spyder Hoe. This equipment, unlike a tracked hoe, would be able to “walk” up the creek channel as well as “step” over obstructions as high as 1.5 m (5 ft) with few or no environmental impacts, and perform the necessary excavations and material placement without placing any extraneous loads on the existing sewer pipe. A Hillsboro, Ore., company was contracted to provide these services.

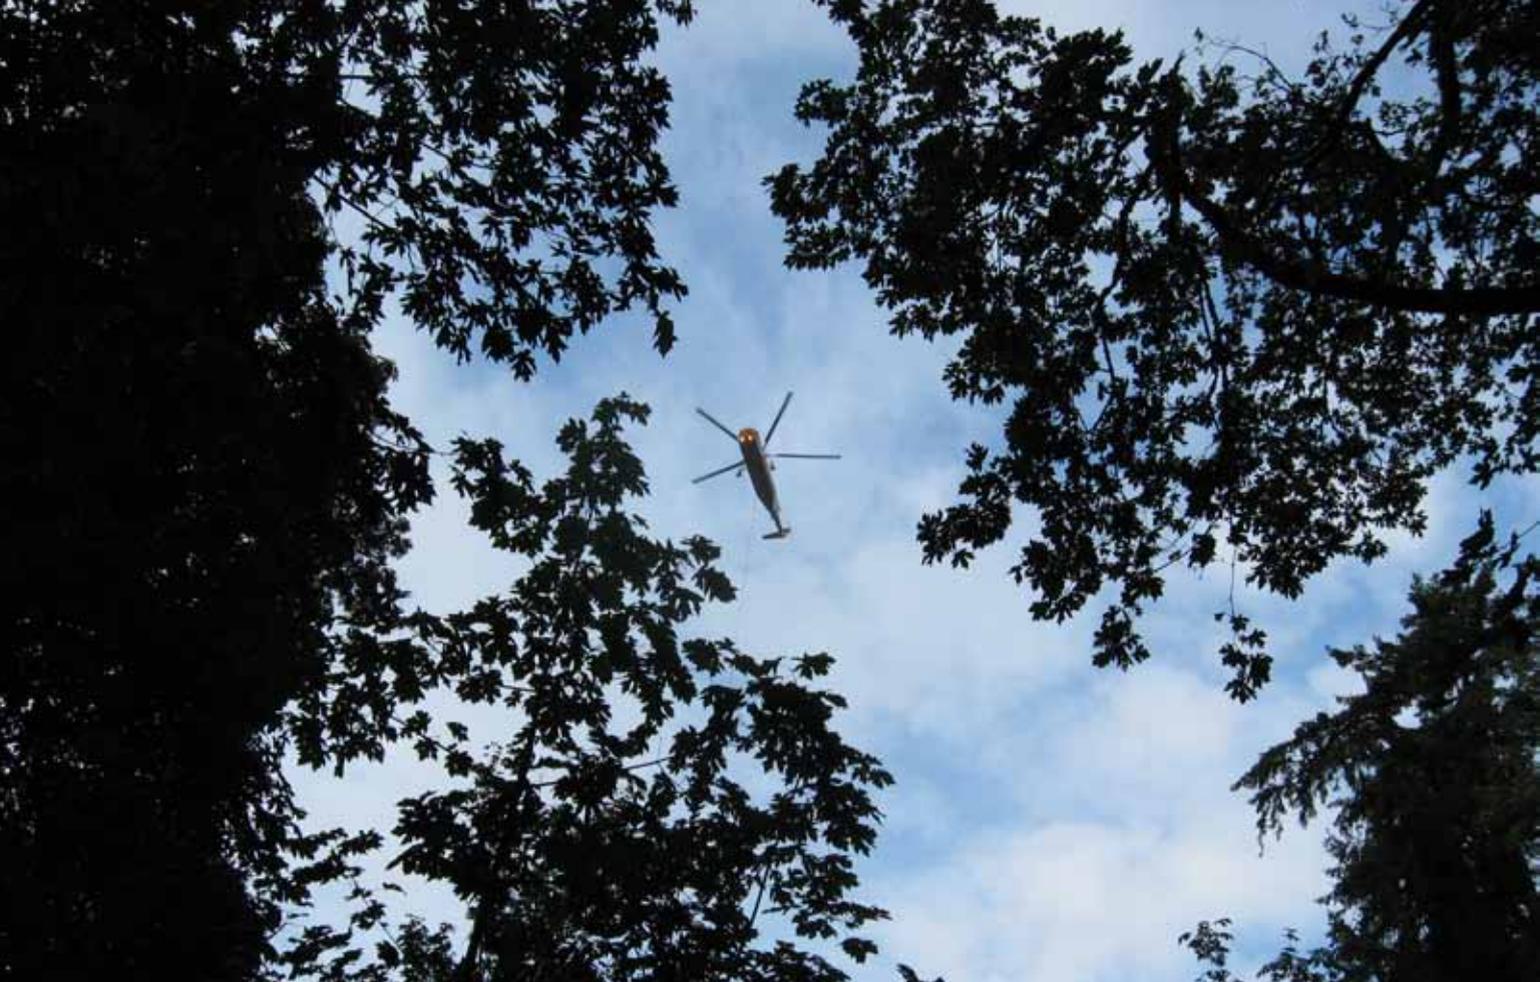
**The proximity of the project to Sea-Tac International Airport required close coordination with the Federal Aviation Administration.** PACE Engineers/SWSSD

**FAA coordination.** Since this project was slightly more than 1.6 km (1 mi) from Sea-Tac International Airport, close coordination with the Federal Aviation Administration (FAA) was required to not only stay out of the airport airspace, but also because the FAA limited the flight path the helicopter could take while transporting materials. Fortunately, the entire location between the staging area and the pipe failures was on forested SWSSD property that contained no houses within the potential crash zone.

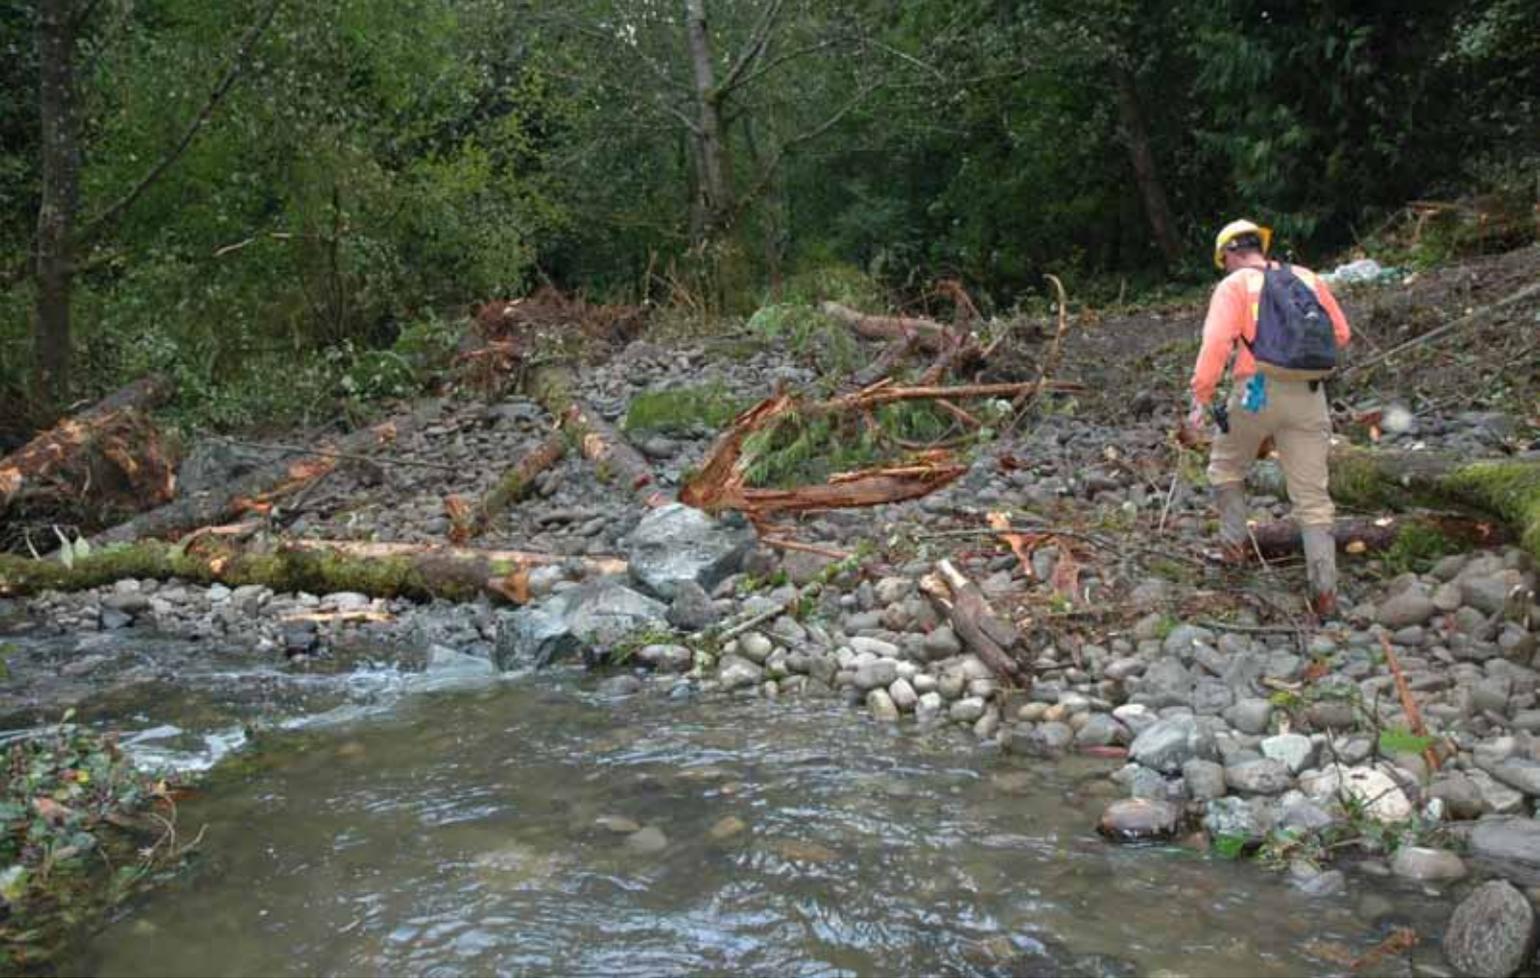
**Post-construction, the stream channel has been raised to its 1966 conditions and constructed to minimize future erosion.** PACE Engineers/SWSSD

**Fish passage.** One of the key elements in securing approval from the resource agencies was to remove an existing fish barrier as part of the streambank and sewer line stabilization. This work involved reconstructing a section of the stream channel that was head-cutting; this was accomplished with a double rock weir in compliance with WSDFW design standards. This collaborative effort between SWSSD and the resource agencies was critical for the success of this project.

Overall, about 360 Mg (400 ton) of material (including logs, boulders, and streambed gravel), two diesel-powered pumps, more than 90 m (300 ft) of suction and discharge hoses, pallets and plywood to build a platform for the pumps, a fuel tank, and sandbags were airlifted. Ultimately, more than 45 m (150 ft) of sewer line were stabilized and more than 90 m (300 ft) of stream were reconstructed. The project was highly successful in not only stabilizing the stream channel and protecting the 750-mm (30-in.) trunk line, but also in removing a fish blockage caused by
